New York State Department of Transportation

Yellow Flag NB2358W009

BIN: 1065318

Location: Span 30, Girder G1 at Pier 30 above the sidewalk at the intersection of 65th Street WB roadway and 4th Avenue.

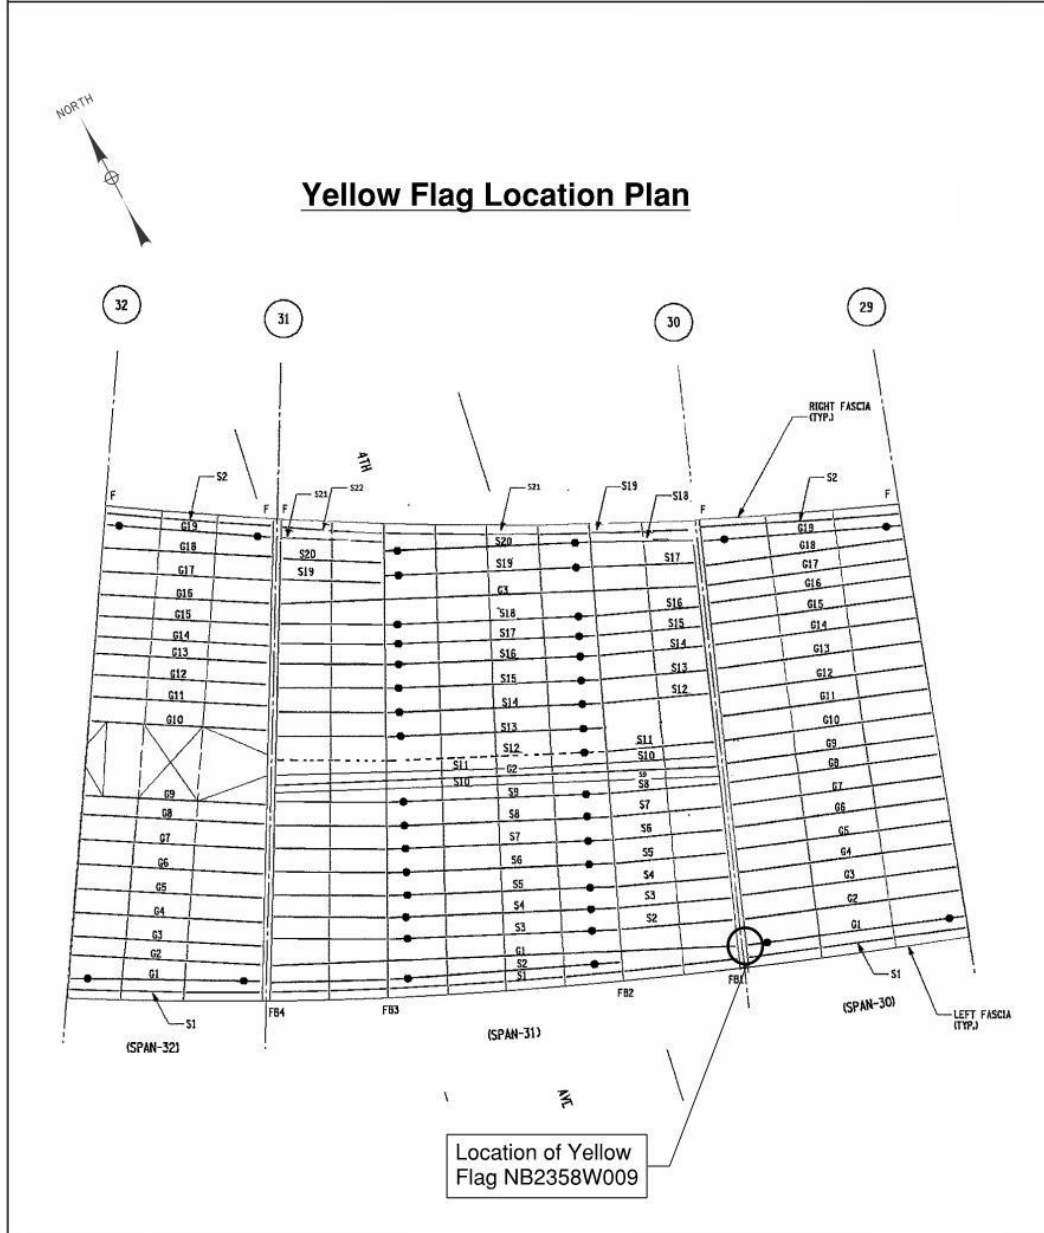
Flag PhotographsPhoto Number: **1**Photo Filename: **23_Flag Location Plan.jpg**Gowanus Expressway
2023 Biennial Inspection - Field SketchBIN: 1065318Team: AA/TSDate: 05/01/2023Span: 30Location: Girder G1 at Pier 30

**Attachment Description: Flag Location Plan**

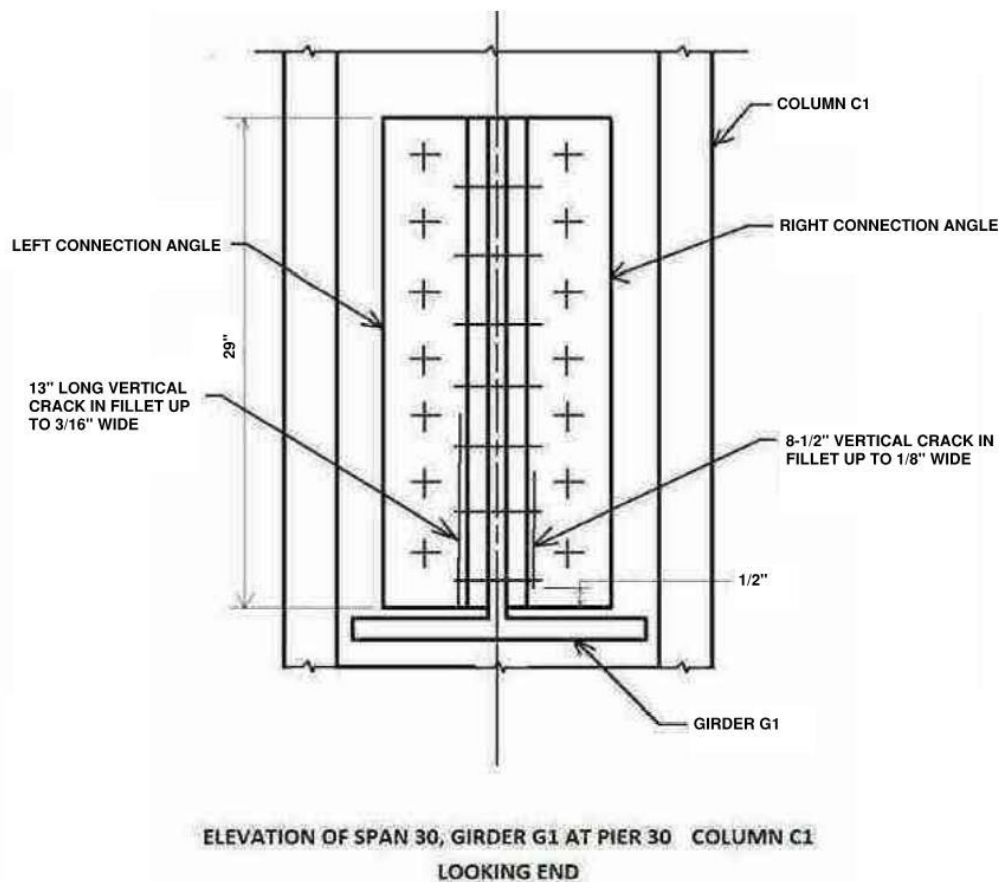
Photo Number: 2

The left connection angle at Girder G1 connection to the Pier 30 capbeam exhibits a 13" long x 3/16" wide vertical crack at the lower fillet section starting at the bottom of the angle (previously documented 12" long x 3/16" wide vertical crack, resulting in the crack increasing approximately 1" in length) (Photo #5). This crack represents a loss of approximately 45% of the angle's total height of 29". The right connection angle at Girder G1 connection to the Pier 30 capbeam exhibits a 8-1/2" long x 1/8" wide vertical crack at the fillet section starting at 1/2" from the bottom of the angle (previously documented 8-3/8" long x 1/8" wide vertical crack, resulting in crack increasing approximately 1/8" in length) (Photo #6). This crack represents a loss of approximately 30% of the angle's total height of 29". (refer to Yellow Flag Condition Sketch #2 for more details)

Yellow Flag Condition Sketch

Attachment Description: Flag Condition Sketch

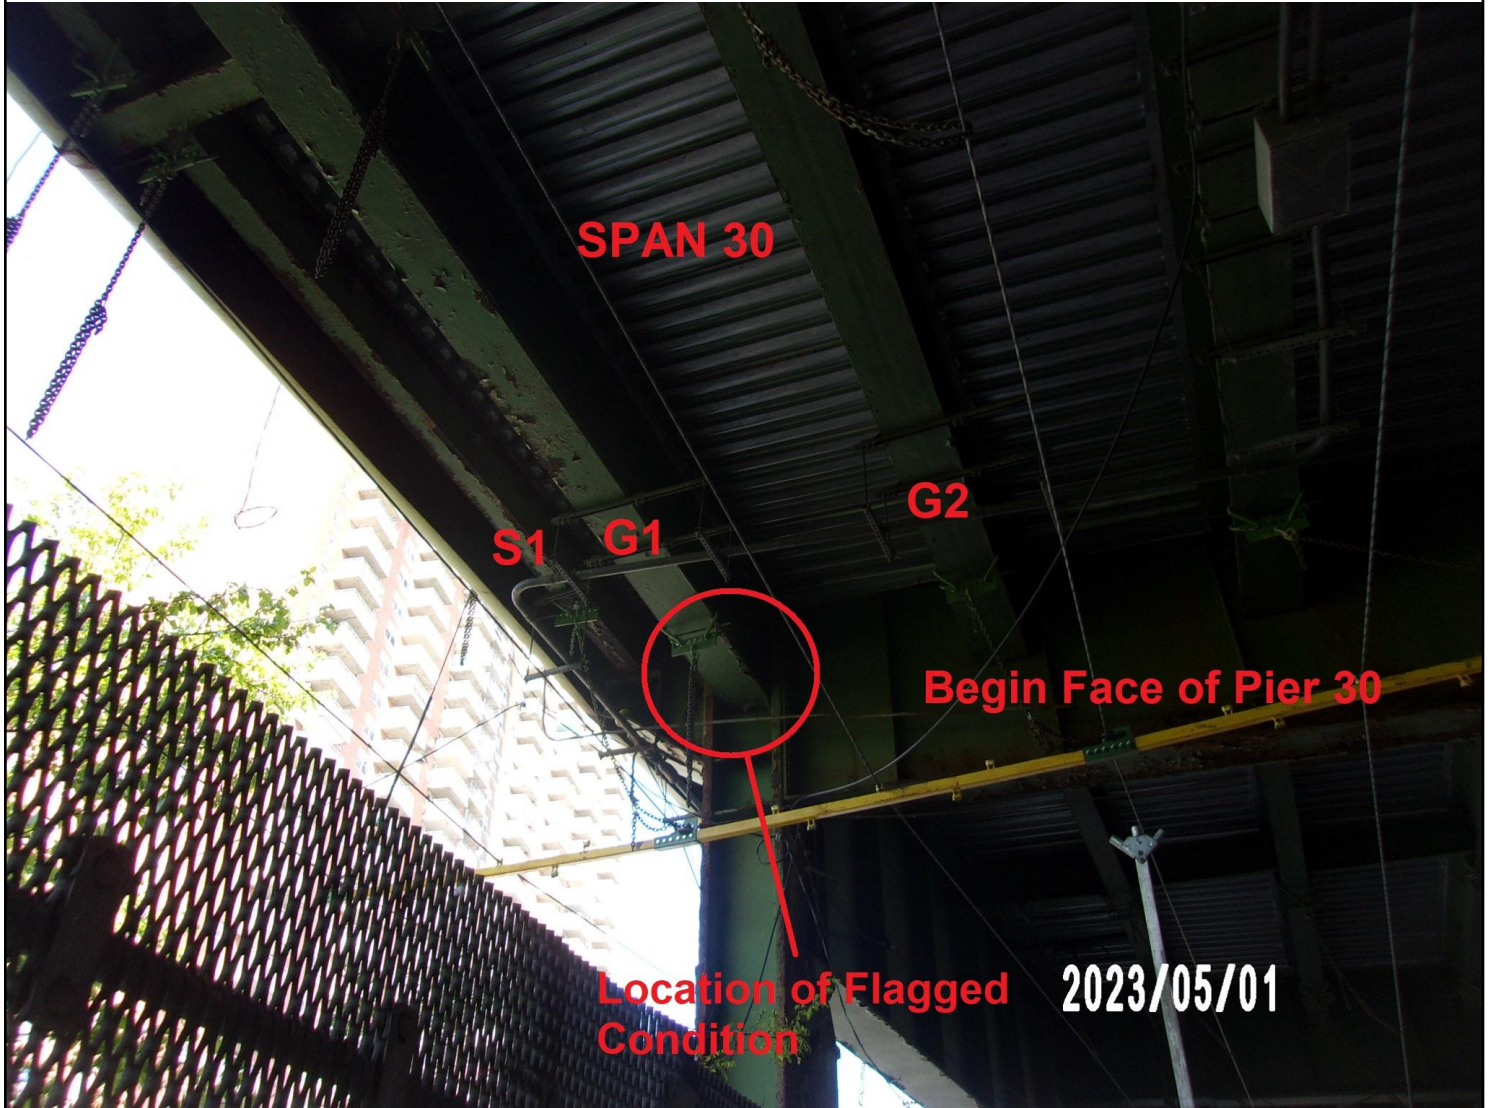
Photo Number: 3

Attachment Description: General view of the flagged condition at Girder G1 in Span 30 at Pier 30. Looking End.

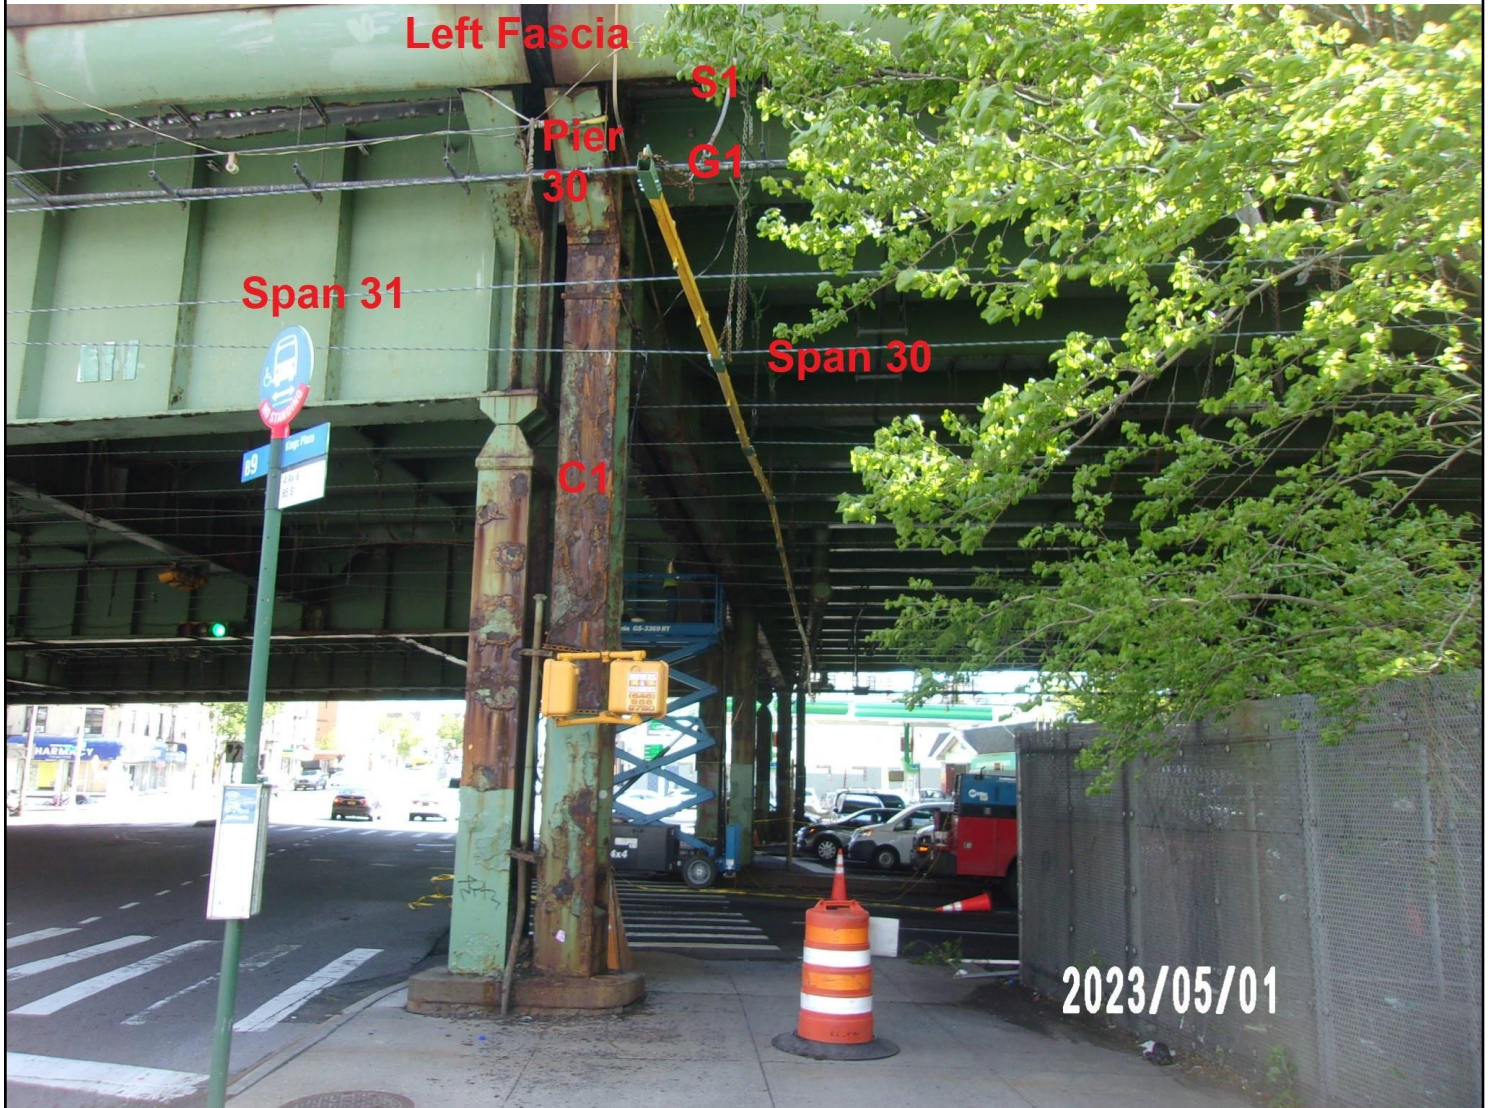
Photo Number: 4

4. Due to the access restrictions from cables in place for the ongoing contractor platform installation in Span 30, the Girder G1 location was accessed with a 30ft bucket truck parked on the sidewalk at the intersection of 65th Street and 4th Avenue. (Photo #4)

Attachment Description: The left side of Girder S1 in Span 30 at Pier 30. The flagged condition at the girder is located above Column C1 and the sidewalk at the intersection of 65th Street and 4th Avenue. Also, there were access restrictions for the stringer due to the cables in place for the ongoing contractor platform installation in Span 30. Looking Right.

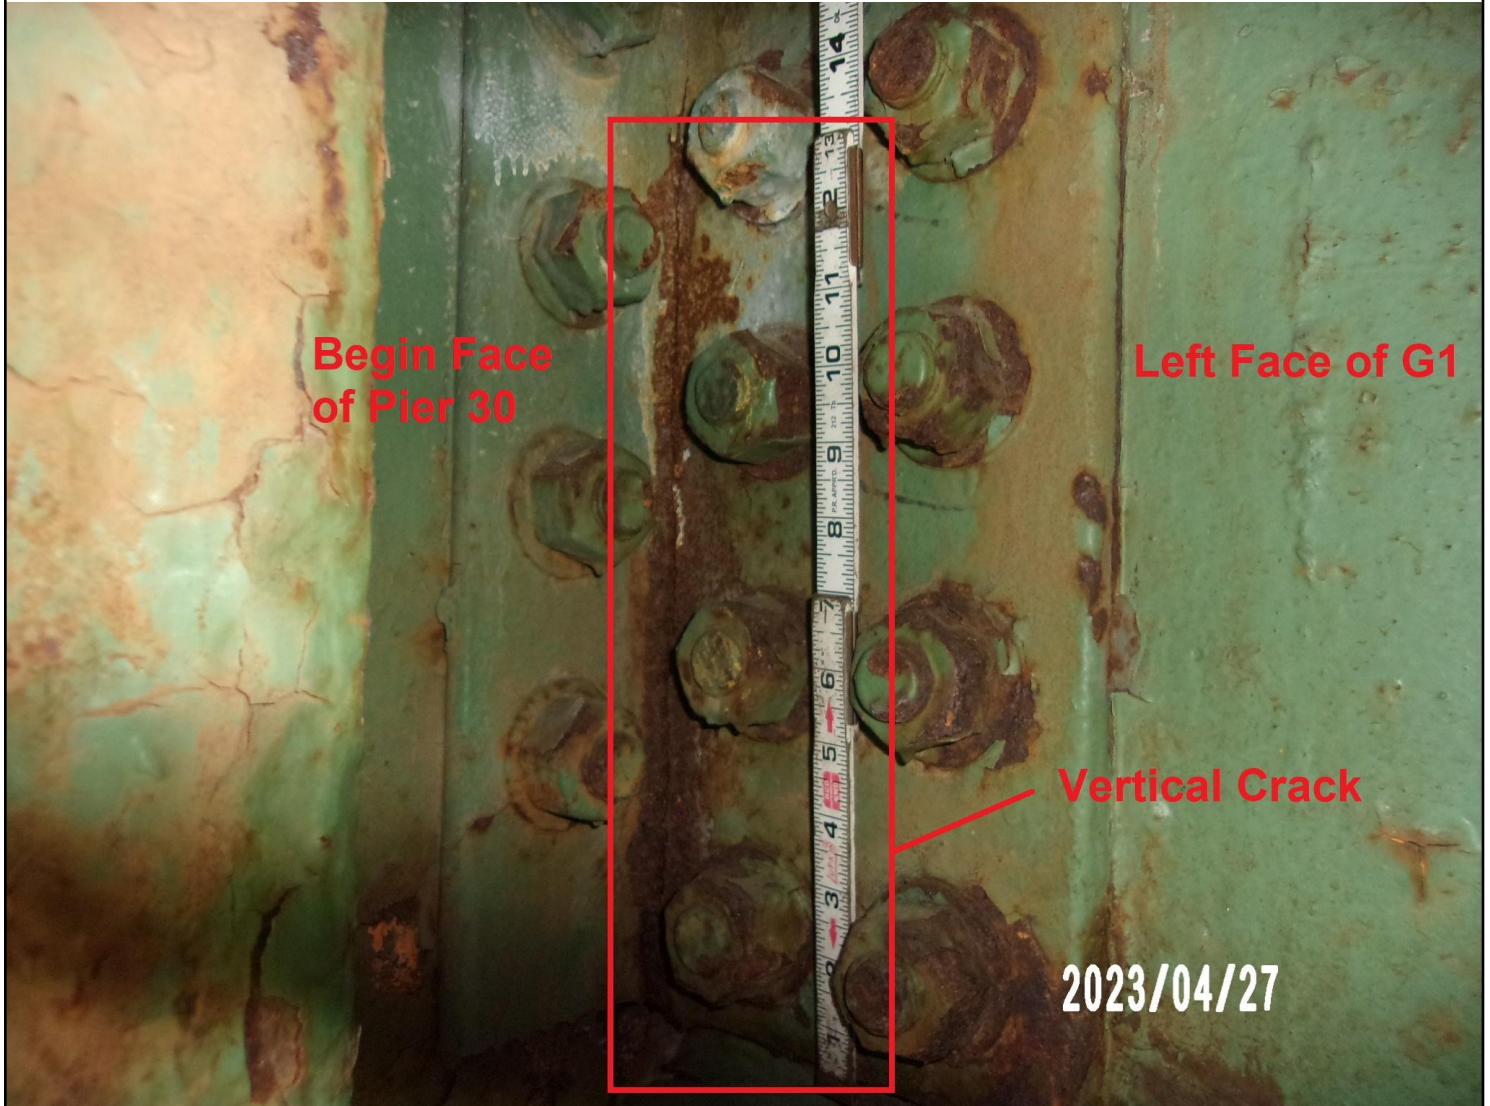
Photo Number: 5

Attachment Description: The left face of Girder G1 in Span 30 at Pier 30. The left connection angle exhibits a 13" long vertical crack in the fillet section at the bottom of the angle. Looking Right.

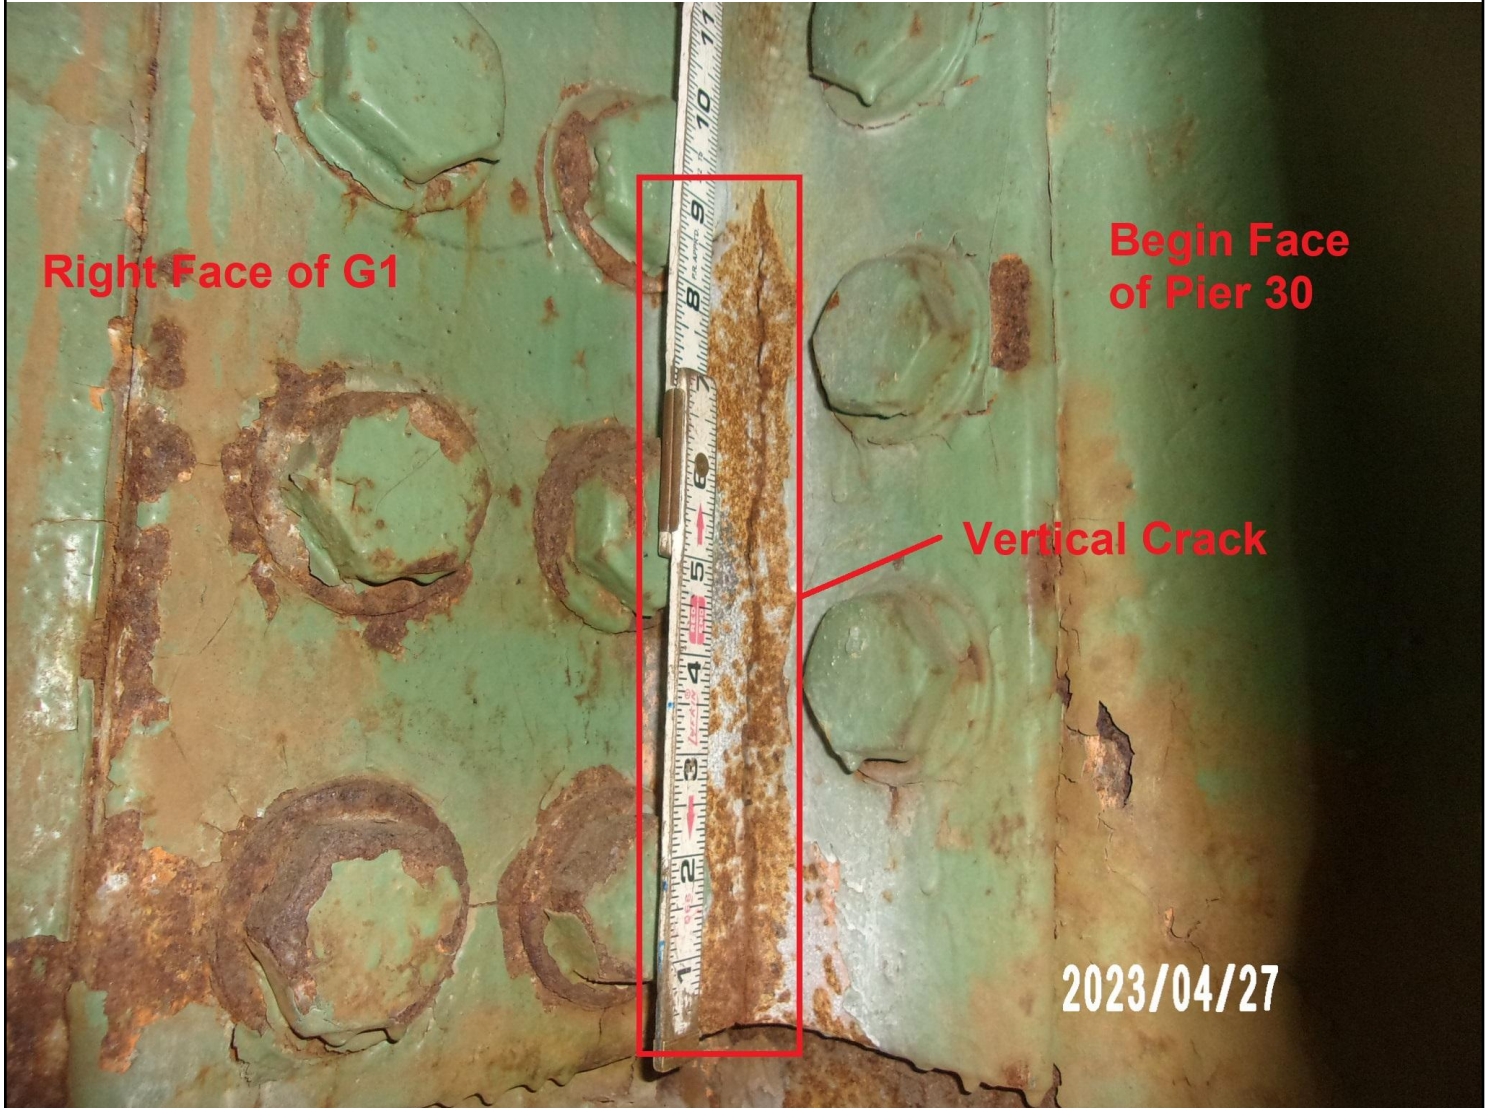
Photo Number: 6

Attachment Description: The right face of Girder G1 in Span 30 at Pier 30. The right connection angle exhibits an 8-1/2" long vertical crack in the fillet section at the bottom of the angle. Looking Left.
